INDOOR AIR QUALITY ASSESSMENT

**Lincoln D. Lynch School
30 Forest Street
Middleborough, MA 02346**

Prepared by:
Massachusetts Department of Public Health
Center for Environmental Health
Emergency Response/Indoor Air Quality Program
May 2006

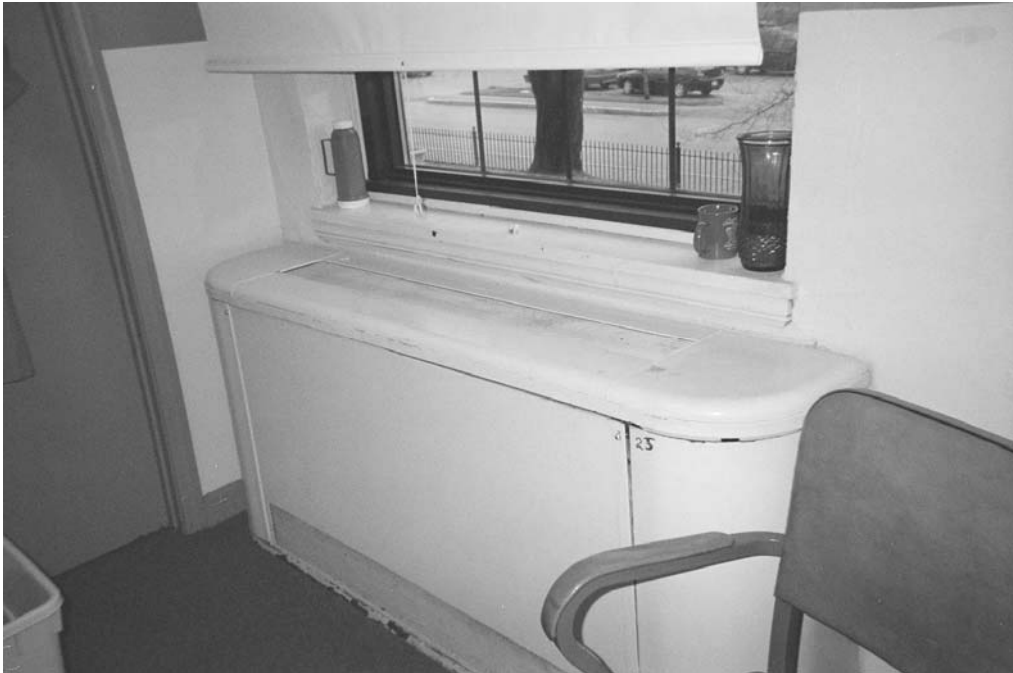
Picture 1

It can be seen from Table 1 that carbon dioxide levels were above 800 parts per million (ppm) in all areas surveyed, indicating inadequate air exchange throughout the school. Fresh air in classrooms is supplied by unit ventilator (univent) systems (Picture 1). A univent is designed to draw air from outdoors through a fresh air intake located on the exterior wall of the building (Picture 2) and return air through an intake located at the base of the unit ([Figure 1](#)). Fresh and return air are mixed and filtered, then heated and provided to classrooms through an air diffuser located in the top of the unit. Univents were operating in all but one area. Obstructions to airflow, such as papers and books stored on univents and bookcases, carts and desks in front of univent returns, were seen in a few classrooms (Picture 3). In order for univents to provide fresh air as designed, units must remain free of obstructions and allowed to operate as designed.

Classroom univent

1. Examine each univent for function. Survey classrooms for univent function to ascertain if an adequate air supply exists for each room. Consider consulting a heating, ventilation and air conditioning (HVAC) engineer concerning the calibration of univent fresh air control dampers.t

2. Operate all ventilation systems that are operable throughout the building (e.g., cafeteria, classrooms) continuously during periods of school occupancy and independent of thermostat control. To increase airflow in classrooms, set univent controls to “high”.

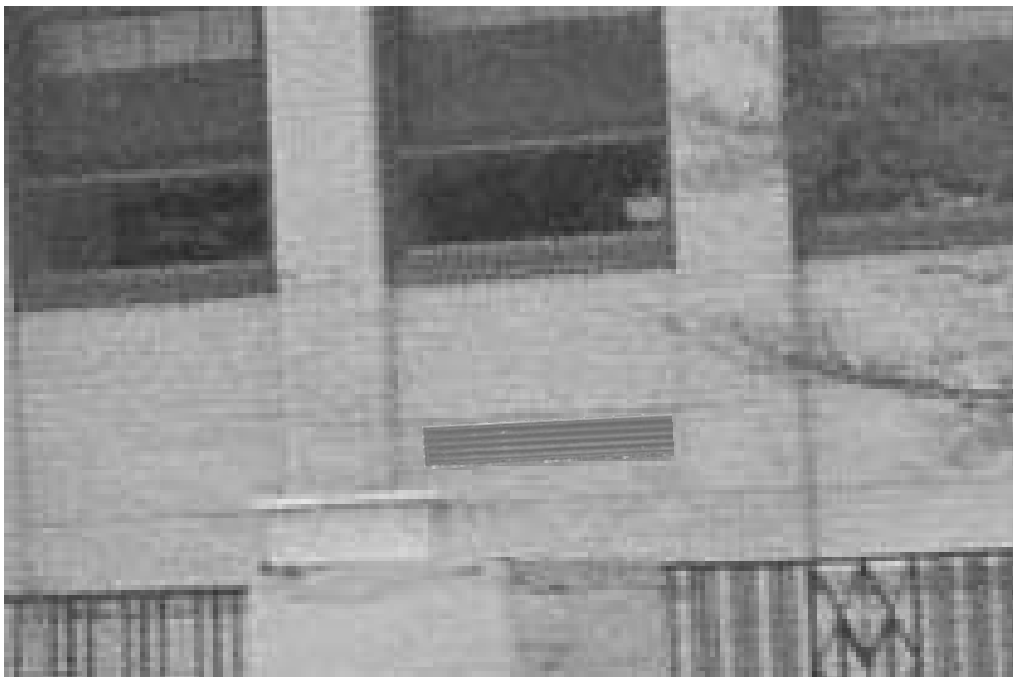
Picture 2

Univent fresh air intake

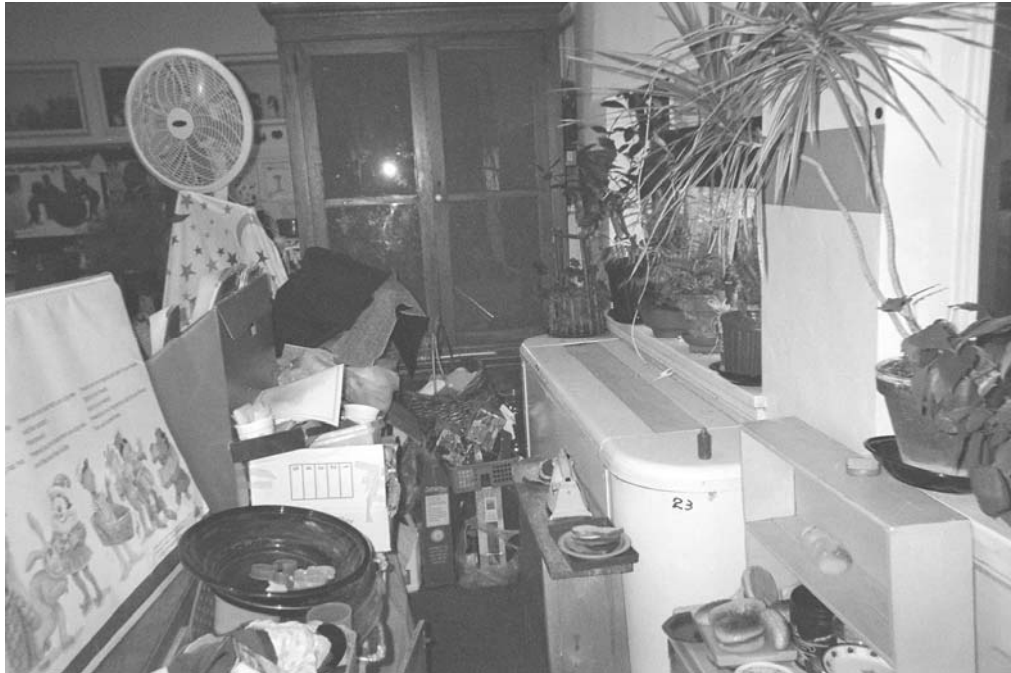
Picture 3

Lastly, plants were noted in several classrooms; some were placed in close proximity to univents (Picture 3). Plants can be a source of pollen and mold, which can be respiratory irritants for some individuals. Plants should be properly maintained and equipped with drip pans. Plants should also be located away from univents to prevent the aerosolization of dirt, pollen or mold.

Also of note was the amount of materials stored inside classrooms. In classrooms throughout the school, items were observed on windowsills, tabletops, counters, bookcases and desks (Picture 3). The large number of items stored in classrooms provides a source for dusts to accumulate. These items (e.g., papers, folders, boxes) make it difficult for custodial staff to clean. Items should be relocated and/or be cleaned periodically to prevent excessive dust build up. A number of personal fans also had accumulated dust. Fans can aerosolize dust accumulated on fan blades when activated.

Univent surrounded by items, note plants near univent diffuser

3. Remove all blockages from univents to ensure adequate airflow.
4. Consider restoring exhaust system or installing motors utilizing existing ductwork to provide mechanical exhaust.

10. Move plants away from univents in classrooms. Avoid over-watering and examine drip pans periodically for mold growth. Disinfect with an appropriate antimicrobial where necessary.

12. Relocate or consider reducing the amount of materials stored in classrooms to allow for more thorough cleaning. Clean items regularly with a wet cloth or sponge to prevent excessive dust build-up.

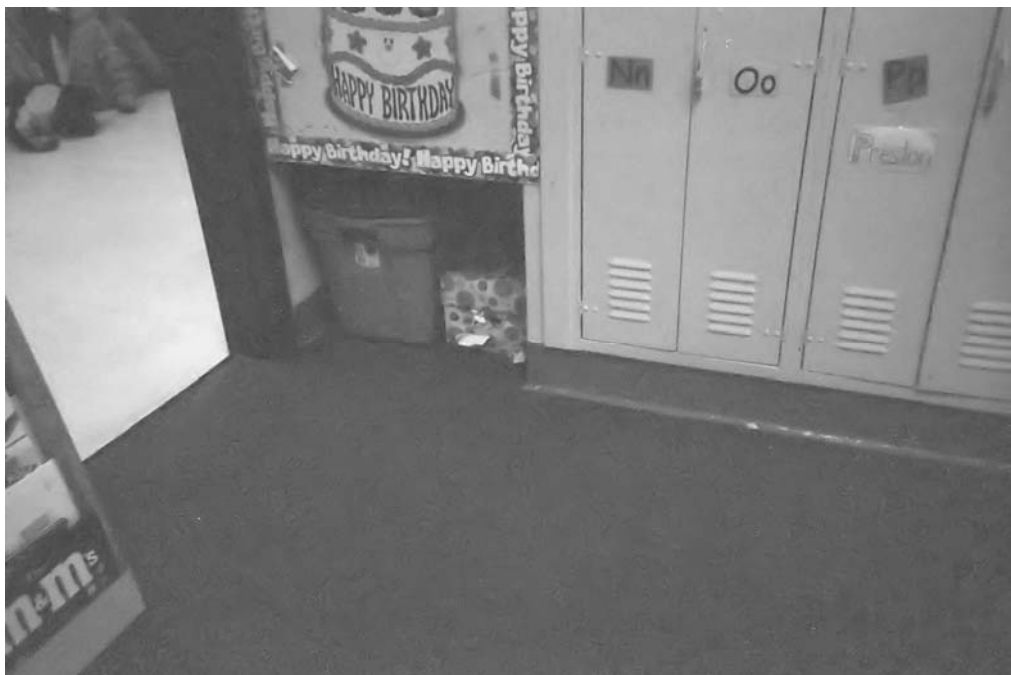
Picture 4

It appears that exhaust ventilation was originally provided to classrooms via gravity exhaust vents; however, this system has been abandoned. Ductwork within the building once allowed air to be drawn from classrooms via a “cubby” opening in the wall (Picture 4). A louver located inside the duct controls airflow. Heating elements within the ductwork create airflow via rising heat, a condition known as “the stack effect”. Under the current circumstances, it appears that the building does not have a functioning exhaust ventilation system. Without sufficient supply and exhaust ventilation, normally occurring environmental pollutants can build up and lead to air quality/comfort complaints. In one room, the wall opening was sealed (Picture 5). If not in use, consideration should be given to sealing all exhaust vents to prevent backdrafting and movement of materials into occupied areas.

“Cubby” exhaust used as storage

5. As a temporary measure or if restoration is not feasible, exhaust vents/shafts should be sealed in classrooms, as well as their termini (e.g., roof, basement) to prevent the migration of debris into occupied areas.

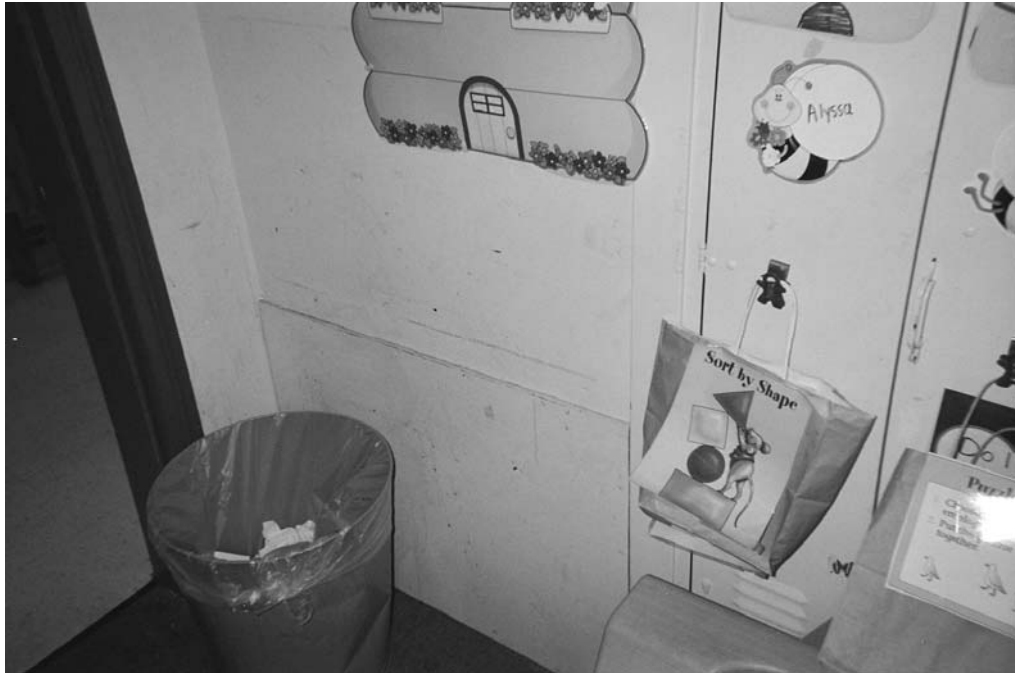
Picture 5

Sealed “cubby” exhaust

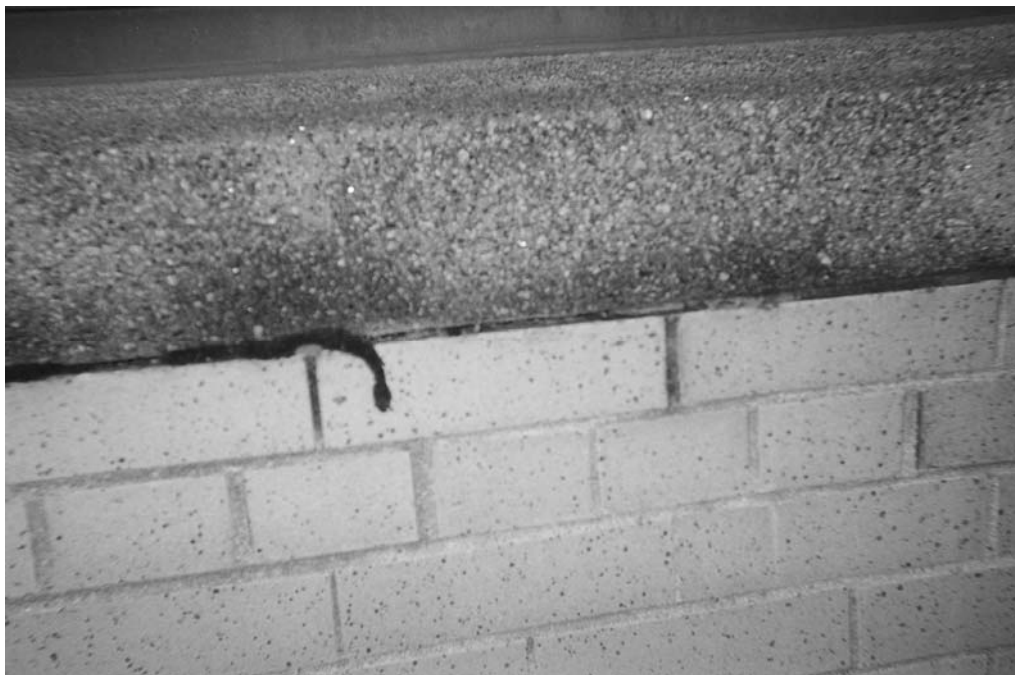
Picture 6

During a perimeter assessment of the LDLS, CEH staff observed moss growth along windows and the building exterior. Such growth indicates moisture is being retained in these areas (Picture 6). CEH staff also observed leaves and other debris gathered at the base of fire escapes (Picture 7) and plant growth against the building exterior. During heavy rains, these materials can prevent proper drainage. The growth of plant roots against exterior walls can bring moisture in contact with the foundation. Plant roots can eventually penetrate, leading to cracks and/or fissures in the sublevel foundation. Over time, this process can undermine the integrity of the building envelope, providing a means of water entry into the building via capillary action through foundation concrete and masonry (Lstiburek & Brennan, 2001). Freezing and thawing during winter months can create further damage. Additional breaches were also noted in the building exterior (Picture 8), which can serve as sources for water penetration.

Moss growth between brick exterior and window ledge

8. Seal breaches in the building exterior to prevent water intrusion, drafts and/or pest entry. Consider repointing building.
9. Remove debris/plants growing around the perimeter of the building to prevent pooling and subsequent water penetrating to the building.

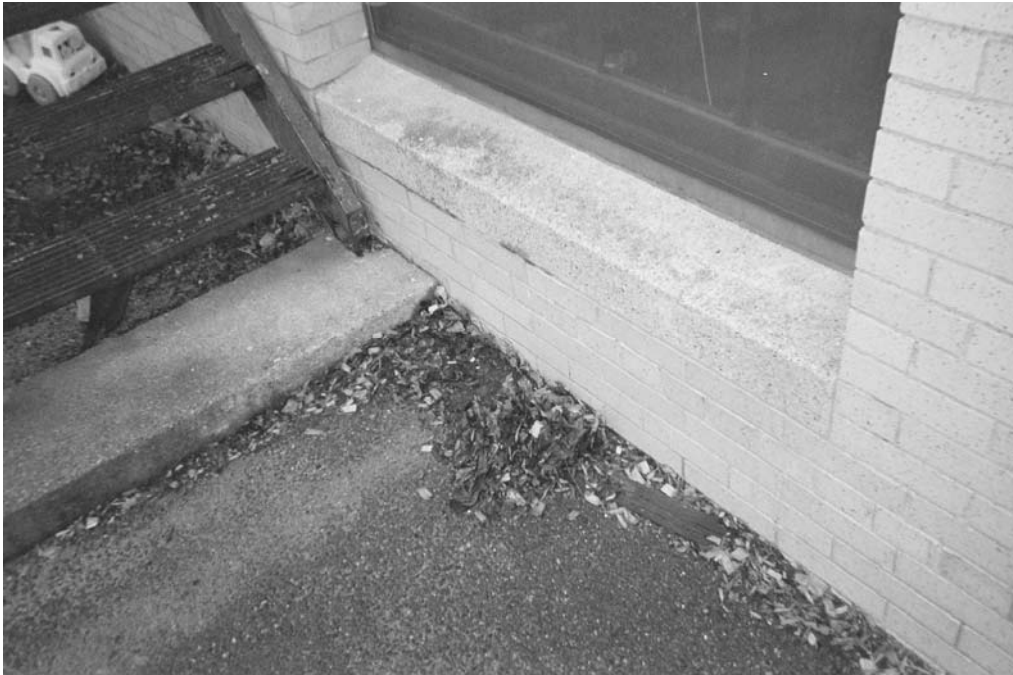
Picture 7

Debris gathered at base of building exterior

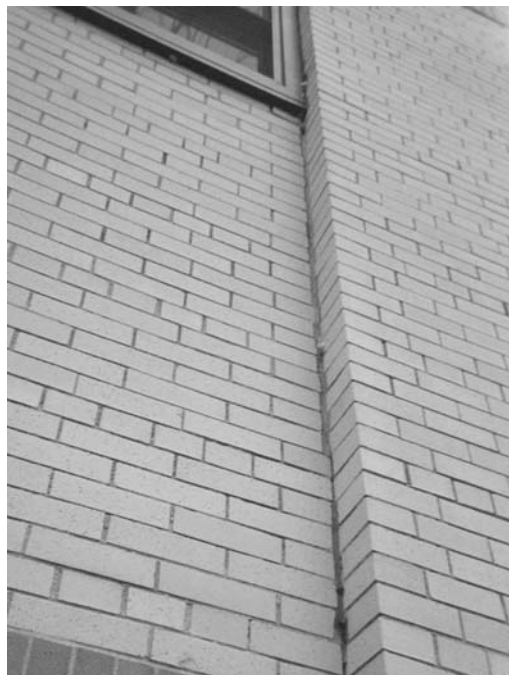
Picture 8

Breach between two facing exterior walls

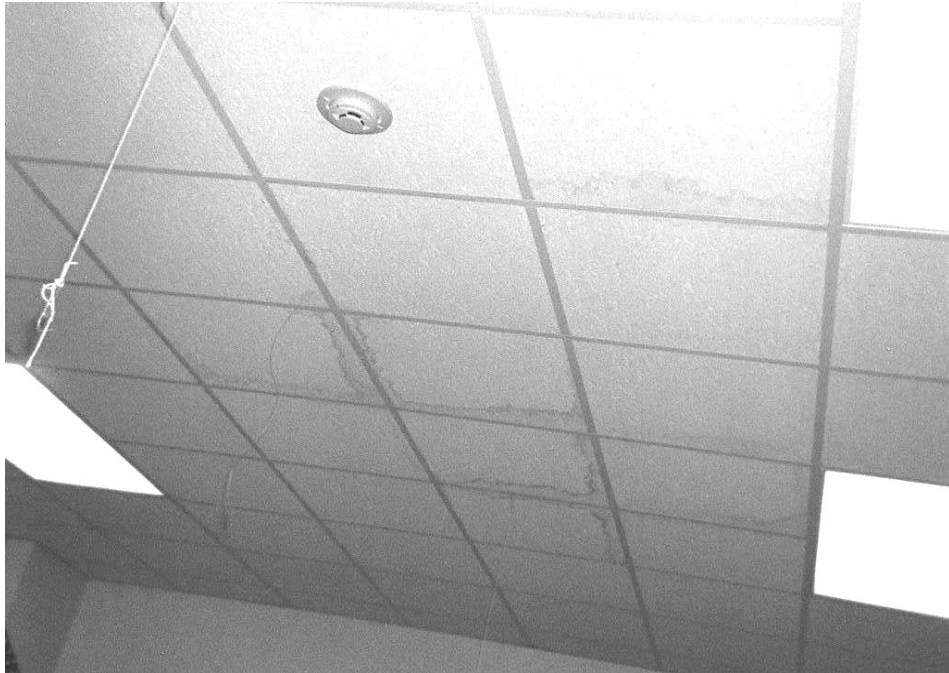
Picture 9

Water damaged ceiling tiles were observed in a number of areas (Picture 9). Water damaged ceiling tiles can indicate that plumbing or roof leaks may exist in the building. Water-damaged ceiling tiles can provide a source for mold and should be replaced after a water leak is discovered and repaired. In one classroom, damage was also observed in areas above water damaged ceiling tiles at the junction where the window frame meets the exterior wall (Picture 10). Such damage would indicate that a breach exists in this area, allowing water to penetrate the building.

Water damaged ceiling tiles

7. Ensure roof/plumbing leaks are repaired, and replace any water stained ceiling tiles. Examine the areas above and around these tiles for mold growth. Disinfect areas of water leaks with an appropriate antimicrobial.

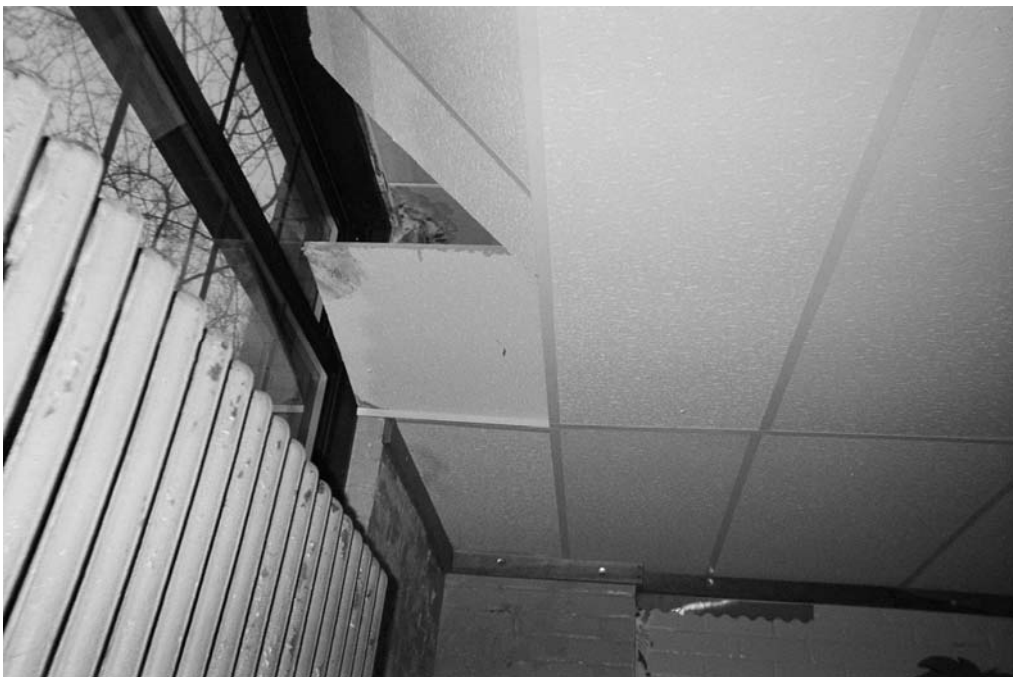
Picture 10

Water damaged ceiling tile near window, note staining above ceiling tile

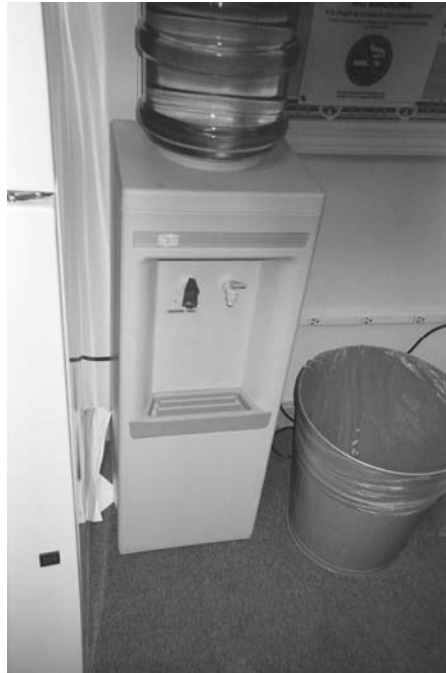
Picture 11

A water cooler was observed on carpeting (Picture 11). Overflow or spillage can moisten carpeting. Catch basins that hold water should also be emptied and cleaned regularly to prevent mold growth and associated odors.

Water cooler on carpeted floor

11. Relocate or place tile or rubber matting underneath water coolers in carpeted areas. Clean and disinfect reservoirs as needed to prevent microbial growth.

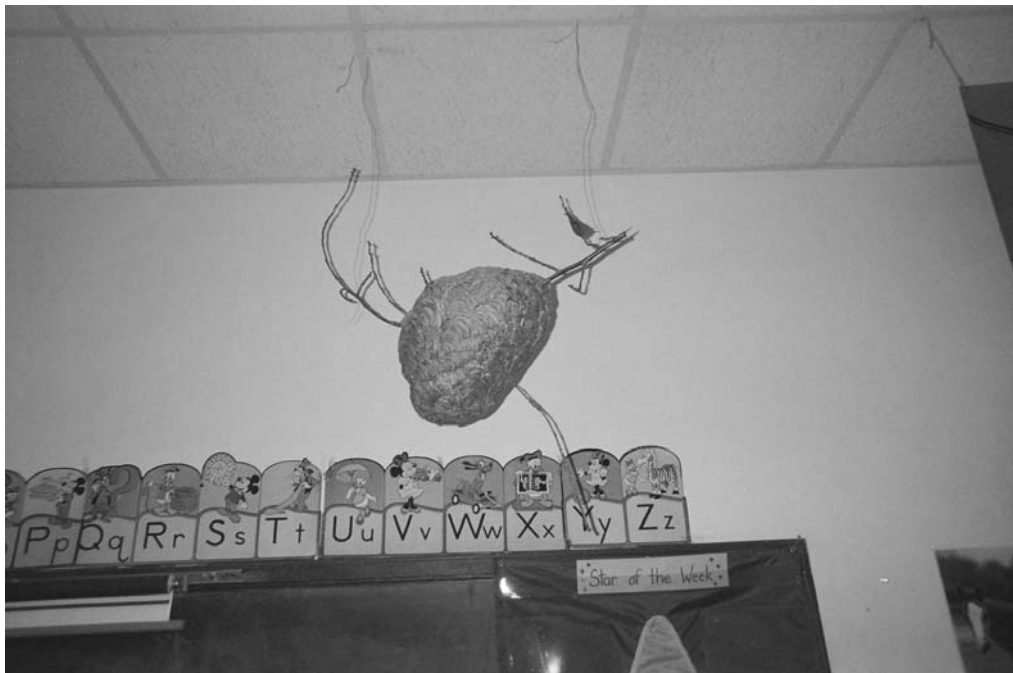
Picture 12

An insect nest was observed suspended from the ceiling tile system (Picture 12). Breaches in continuity to a ceiling tile system can allow dirt, debris and other materials into occupied areas. Nests can contain bacteria and may also be a source of allergenic material. Nests should be placed in resealable bags or containers to prevent aerosolization of allergenic material.

Insect nest suspended from ceiling tile system

14. Place nests in resealable containers or bags to prevent aerosolization of allergenic materials.
15. Refrain from suspending items from the ceiling tile system to prevent movement of particles into occupied spaces.
16. Remove insulation from vent, and ensure it is sealed from both the interior and exterior walls.
17. Consider adopting the US EPA (2000b) document, “Tools for Schools”, to maintain a good indoor air quality environment on the building. This document can be downloaded from the Internet at: <http://www.epa.gov/iaq/schools/index.html>.
18. Refer to resource manuals and other related indoor air quality documents for further building-wide evaluations and advice on maintaining public buildings. These materials are located on the MDPH’s website at http://mass.gov/dph/indoor_air

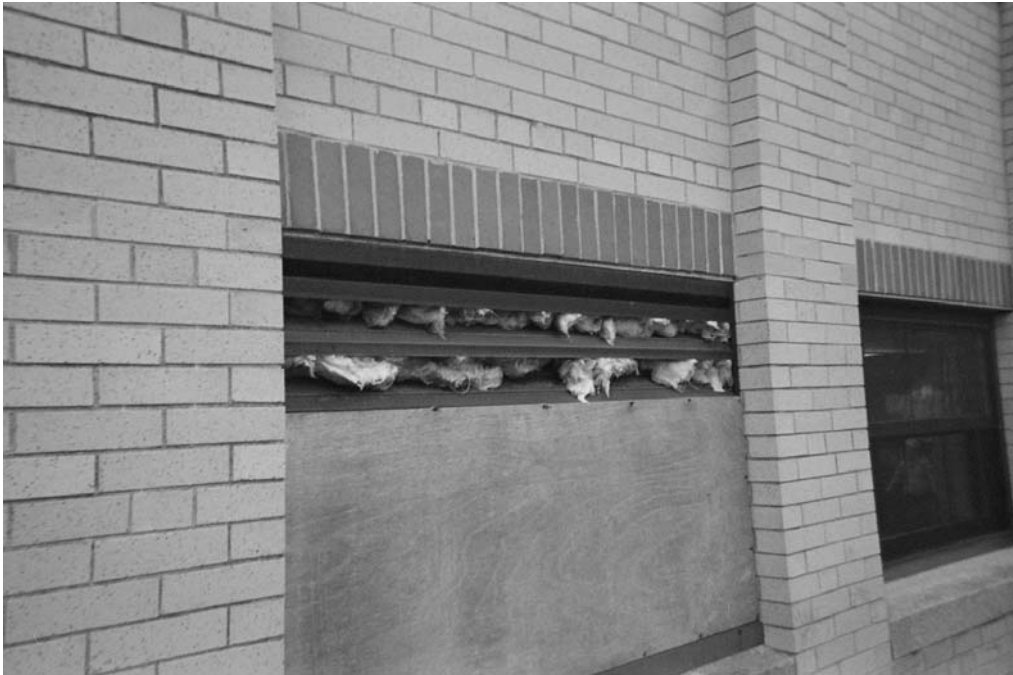
Picture 13

Lastly, an exterior intake vent was sealed with a wooden board and fiberglass insulation. The insulation can become a source for microbial growth and odors. These odors and moisture can penetrate the building if the vent is not sealed on the interior side of the building. The insulation material should be removed, and the vent should be resealed if not in use.

Insulation used to seal vent
